TITLE: Clinical problems in aviation medicine--evaluation of an alleged case of radiation induced cataract at a radar site.

Evaluation of an Alleged Case of Radiation Induced Cataract at a Radar Site

JOHN D. DOUGHERTY, M.D., JOSEPH C. CALDWELL, B.S., WILLIAM M. HOWE, B.S.,
and MAJOR WILLIAM B. CLARK, USAF, MC

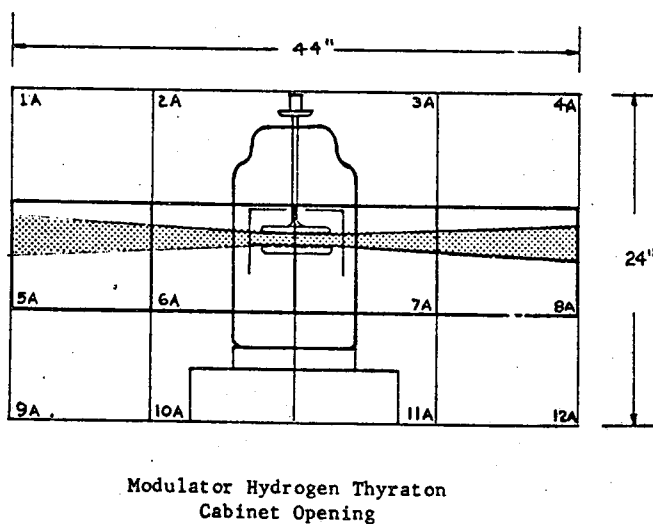
Fig. 3. Film plate arrangement showing radiation pattern.

The actual radiation pattern is close to the theoretical pattern pictured by the appropriate USAF Tech Order (Figure 3). No other radiation was detected on the ad-

joining plates. This band of radiation is so located that it is blocked even with the steel door open to the inspection position (Figure 1).

Tests with film packs outside the steel cabinet door showed no measurable radiation with the doors open only to the inspection position or to the closed position. Each door is interlocked and procedures require that the doors be closed during normal operations.

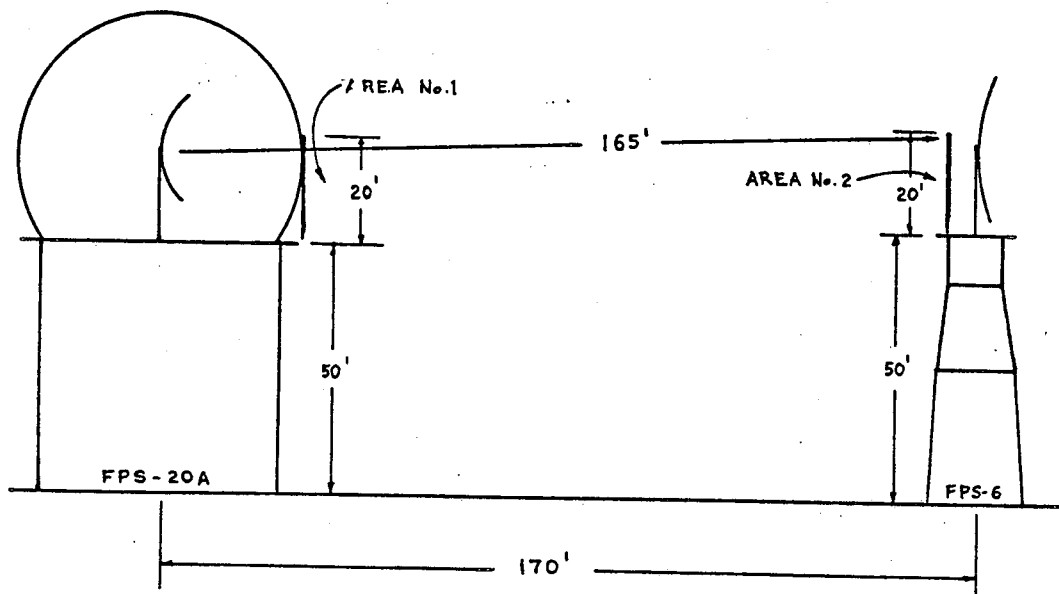
Fig. 4. Survey Conditions.

Initial tests of the RF field power density were inconclusive in that no detectable level was found. These tests were repeated with another instrument of different type which verified a very low RF power level on the FPS-20A antenna catwalk external to the radome and at the maximum accessible level on the FPS-6 height finder tower (Figure 4, area 2). These tests indicated that the main beam of the FPS-20A searched an area which was not accessible to technicians at any time.

1. FPS-20A
 - a. Antenna tilt *classified*
 - b. Antenna azimuth *centered on FPS-6 Tower*
 - c. Transmitter output *6KW Ave. Pwr.*
2. FPS-6
 - a. In standby condition, transmitter *off.*

3. Area #1 dimensions, 0 to 20 ft. above FPS-20 antenna deck.
4. Area #1 detector meter reading *0 MW/CM².*
5. Area #2 dimensions, 0 to 20 ft. above FPS-6 antenna deck.
6. Area #2 detector meter reading *0 MW/CM².*
7. All readings taken with Sperry Electromagnetic Radiation Detector Model B86B1.

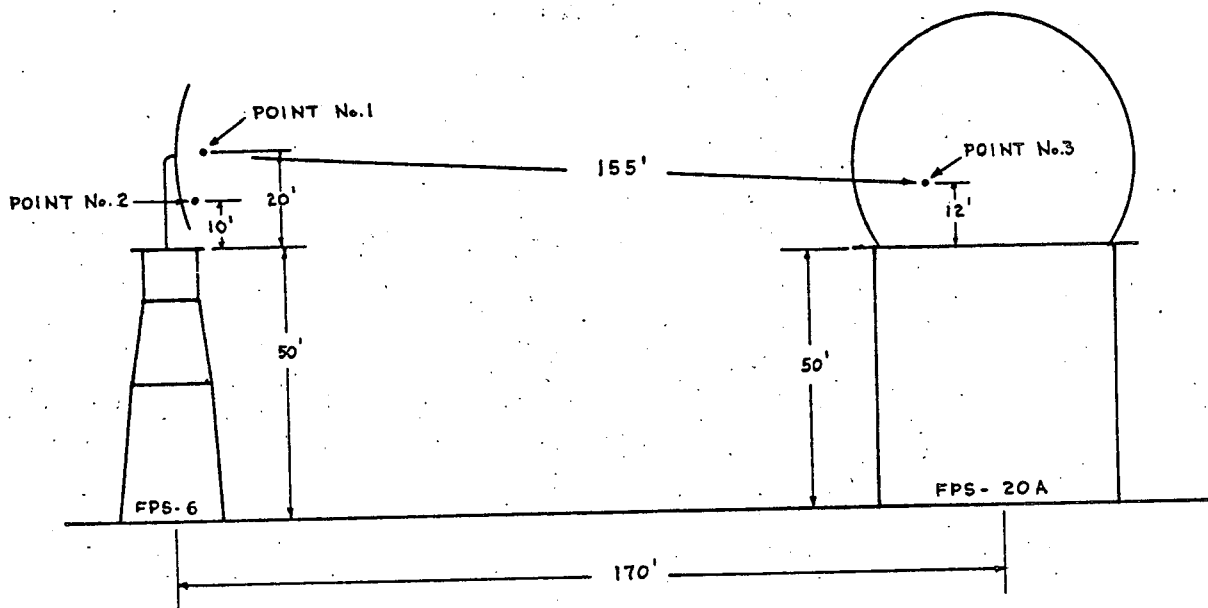
Fig. 5. Survey conditions.

Similarly, the effects of FPS-6 height finder radar on personnel working on the FPS-20A tower were determined by utilizing survey instrument and adjusting antenna tilt of FPS-6 so that the FPS-20A tower catwalk was illuminated (Figure 5). This test also revealed no significant RF power density being experienced due to the FPS-6 antenna. In addition, the FPS-6 height finder antenna and radar equipment is gated, or blanked, to prevent the FPS-6 radar from searchlighting the FPS-20A antenna system. At this point all technical testing was finished with no hazard found. However, the individual technician was still concerned about his original diagnosis.

1. FPS-6
 - a. Antenna tilt locked at -2 degrees.
 - b. Antenna azimuth centered on FPS-20 tower.
 - c. Transmitter output 3.1KW Ave. Pwr.
2. FPS-20

- a. In standby condition, transmitter off.
3. Point #1 detector meter reading 10 MW/CM².
4. Point #2 detector meter reading 10 MW/CM².
5. Point #3 detector meter reading 0 MW/CM².
6. All readings taken with Sperry Electromagnetic Radiation Detector Model B86B1.
