INFORMAL REPORT ON OBSERVATIONS AND RF FIELD INTENSITY MEASUREMENTS MADE AT
A COMMERCIAL FM/TV TOWER LOCATED IN EL PASO, TEXAS

Glaser

Notes* on a site visit made on the 11th of December 1978, with OSHA staff (by invitation) to a TV and FM broadcast/transmitter station and transmitting antenna tower located in El Paso, Texas. The objective of the visit was to determine if employees working in the monitoring building at the base of the transmitting antenna tower, or employees working on the antenna tower itself, are exposed to hazardous levels of radiofrequency (RF) energy. Survey results indicate that RF levels in the monitoring building were well below the present OSHA guideline of 10 mW/cm². RF levels measured on the transmitting antenna tower (located on a mountaintop north of the city) exceeded the OSHA guideline by a factor of 10.

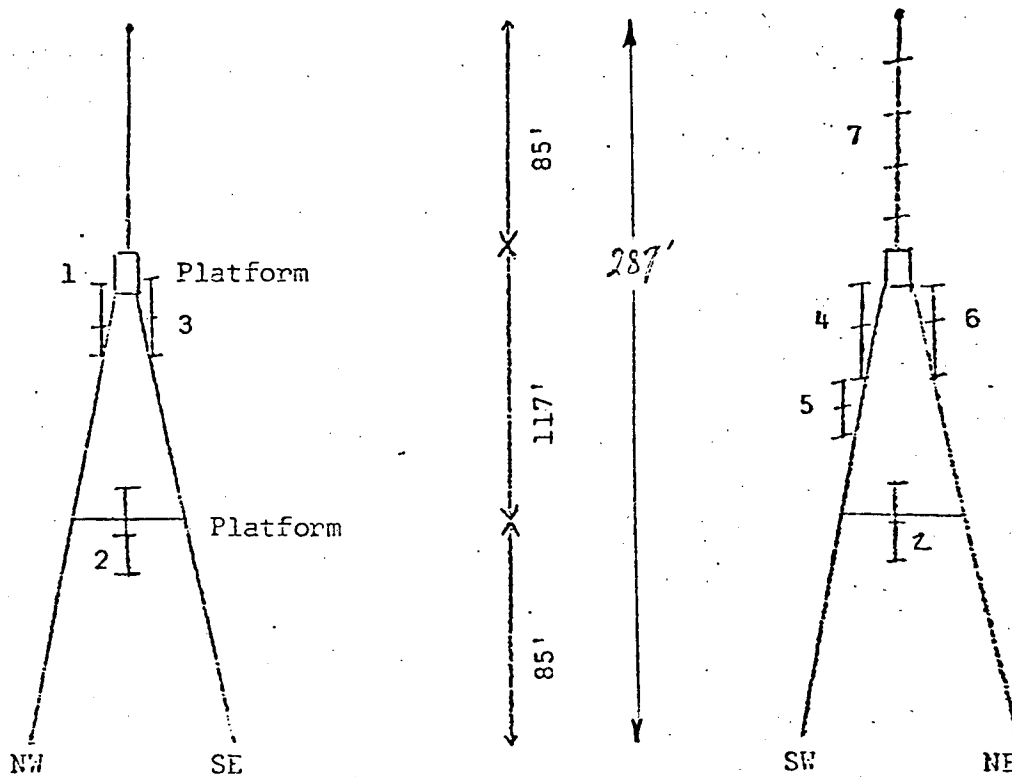
Figure 1: Antenna specifications and relative location on the steel tower.

Note: Transmitter building is located 10 feet south of the tower.

<u>Frequency</u>	<u>RF Power</u>	<u>Antenna</u>	<u>Comments</u>
1. KIMT FM Radio	97.3 MHz	18 KW	6 bay	
2. KTEP FM Radio	88.1 MHz	1 KW	4 bay	
3. KPAS FM Radio	93.9 MHz	20 KW	6 bay	Not currently operating
4. KLOZ FM Radio	102.1 MHz	10 KW	6 bay	
5. KPAS FM Radio	93.9 MHz	20 KW	2 bay	Temporary antenna
6. KAMA FM Radio	93.1 MHz	10 KW	6 bay	
7. KDBC TV-4	60-72 MHz	6 KW video 1.3KW aural	6 bay turnstyle	
8. Additional low-power (~50 W) transmitting antennas (not shown) for 2-way communication systems (operating in the frequency band between 150-400 MHz).

contains information relating to the approximate position of the various antennas, and the call letters of the various stations using the assortment of antennas. The TV antenna and the main FM antenna operated by this station were on the tower owned by the station. The other users were renting space on the tower for their antennas. This apparently is a common situation.
