INFORMAL REPORT ON OBSERVATIONS AND RF FIELD INTENSITY MEASUREMENTS MADE AT
A COMMERCIAL FM/TV TOWER LOCATED IN EL PASO, TEXAS

Notes* on a site visit made on the 11th of December 1978, with OSHA staff (by invitation) to a TV and FM broadcast/transmitter station and transmitting antenna tower located in El Paso, Texas. The objective of the visit was to determine if employees working in the monitoring building at the base of the transmitting antenna tower, or employees working on the antenna tower itself, are exposed to hazardous levels of radiofrequency (RF) energy. Survey results indicate that RF levels in the monitoring building were well below the present OSHA guideline of 10 mW/cm^2 . RF levels measured on the transmitting antenna tower (located on a mountaintop north of the city) exceeded the OSHA guideline by a factor of 10.

By: Zory R. Glaser, NIOSH, and Robert Curtis, OSHA.

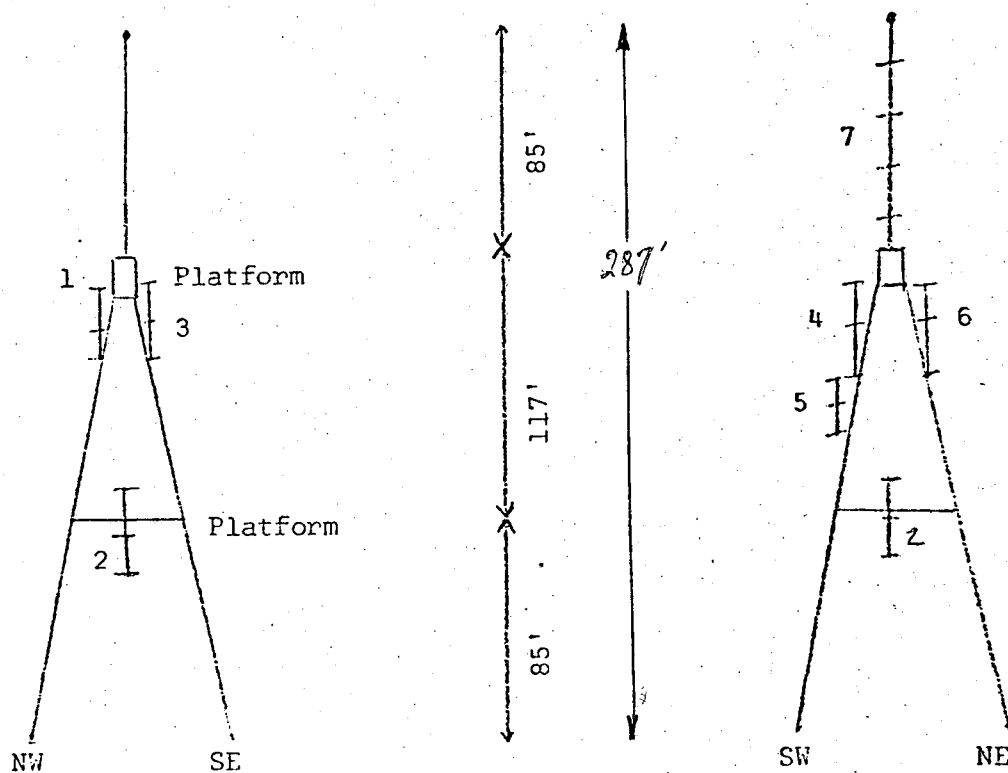
Figure 1: Antenna specifications and relative location on the steel tower.

Note: Transmitter building is located 10 feet south of the tower.

<u>Frequency</u>	<u>RF Power</u>	<u>Antenna</u>	<u>Comments</u>
1. KIMT FM Radio	97.3 MHz	18 KW	6 bay	
2. KTEP FM Radio	88.1 MHz	1 KW	4 bay	
3. KPAS FM Radio	93.9 MHz	20 KW	6 bay	Not currently operating
4. KLOZ FM Radio	102.1 MHz	10 KW	6 bay	
5. KPAS FM Radio	93.9 MHz	20 KW	2 bay	Temporary antenna
6. KAMA FM Radio	93.1 MHz	10 KW	6 bay	
7. KDBC TV-4	60-72 MHz	6 KW video 1.3KW aural	6 bay turnstyle	
8. Additional low-power (~50 W) transmitting antennas (not shown) for 2-way communication systems (operating in the frequency band between 150-400 MHz).

contains information relating to the approximate position of the various antennas, and the call letters of the various stations using the assortment of antennas. The TV antenna and the main FM antenna operated by this station were on the tower owned by the station. The other users were renting space on the tower for their antennas. This apparently is a common situation.
